TRINITY CHURCH DAM

NDI ID NO. MD-37

PHASE I INSPECTION REPORT

NATIONAL DAM INSPECTION PROGRAM

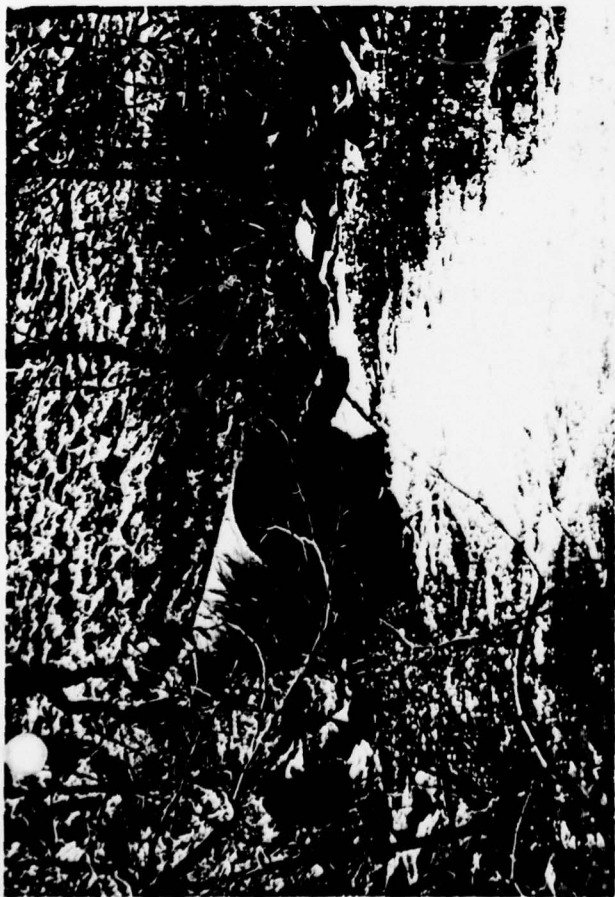
5

- 3) Seepage. No springs or seeps were observed emanating from the downstream toe area of the dam. The two 8 in. dia. seepage drain outlets are partially submerged by plunge pool tailwater but appear to be flowing (est. 0.5 gpm ea.) and transporting a brown iron precipitate (see Photograph 5). These pipes are partially rusted.

The two 8 in. dia. seepage drain pipe outlets were found to be partially submerged by the tailwater level of the plunge pool. An increase in tailwater level due to possible obstruction of the outlet channel could completely submerge these outlets and reduce the efficiency of the seepage drains.

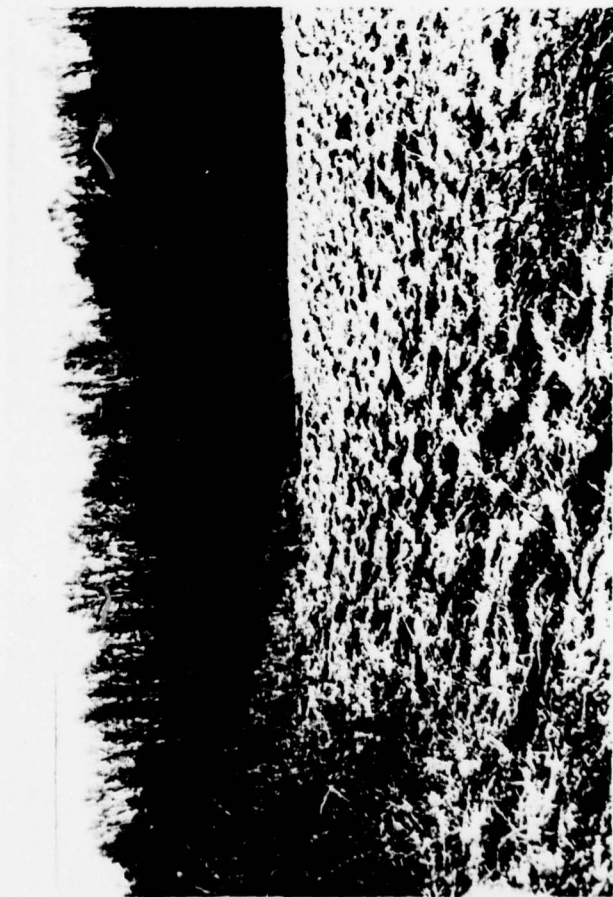
- 4) Wet Zones. Wet zones were observed approximately 20 to 100 ft. downstream and parallel to the downstream embankment toe, both right and left of the plunge pool. This condition was more pronounced on the right side of the plunge pool. Both areas are in topographic lows (see photograph nos. 7 and 8).

- 2) Wet Zones. Wet zones downstream of the embankment toe, noted in Section 3.1-b(4), are not considered to represent significant hazard to embankment stability. The wet zones are not believed to be the result of seepage emanating from the embankment.

- 1) Periodically observe wet zones indicated in Section 3.1-b(4). Report any evidence of seepage emanating from the embankment or change in condition to the Maryland Water Resources Administration and the Soil Conservation Service. Make remedial corrections, as conditions require.

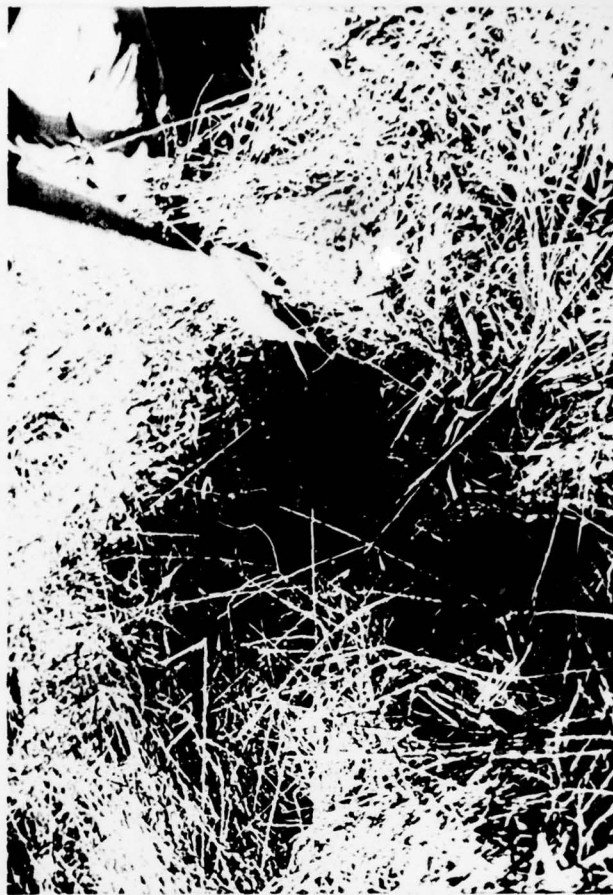
8

Close-up view of wet zone.
